Machine : Cranial **Drills/Motor**

NON-**DISENGAGEMENT OF CRANIAL DRILLS :** Risk of haemorrhage and risk of damage to the dura mater, haematomas

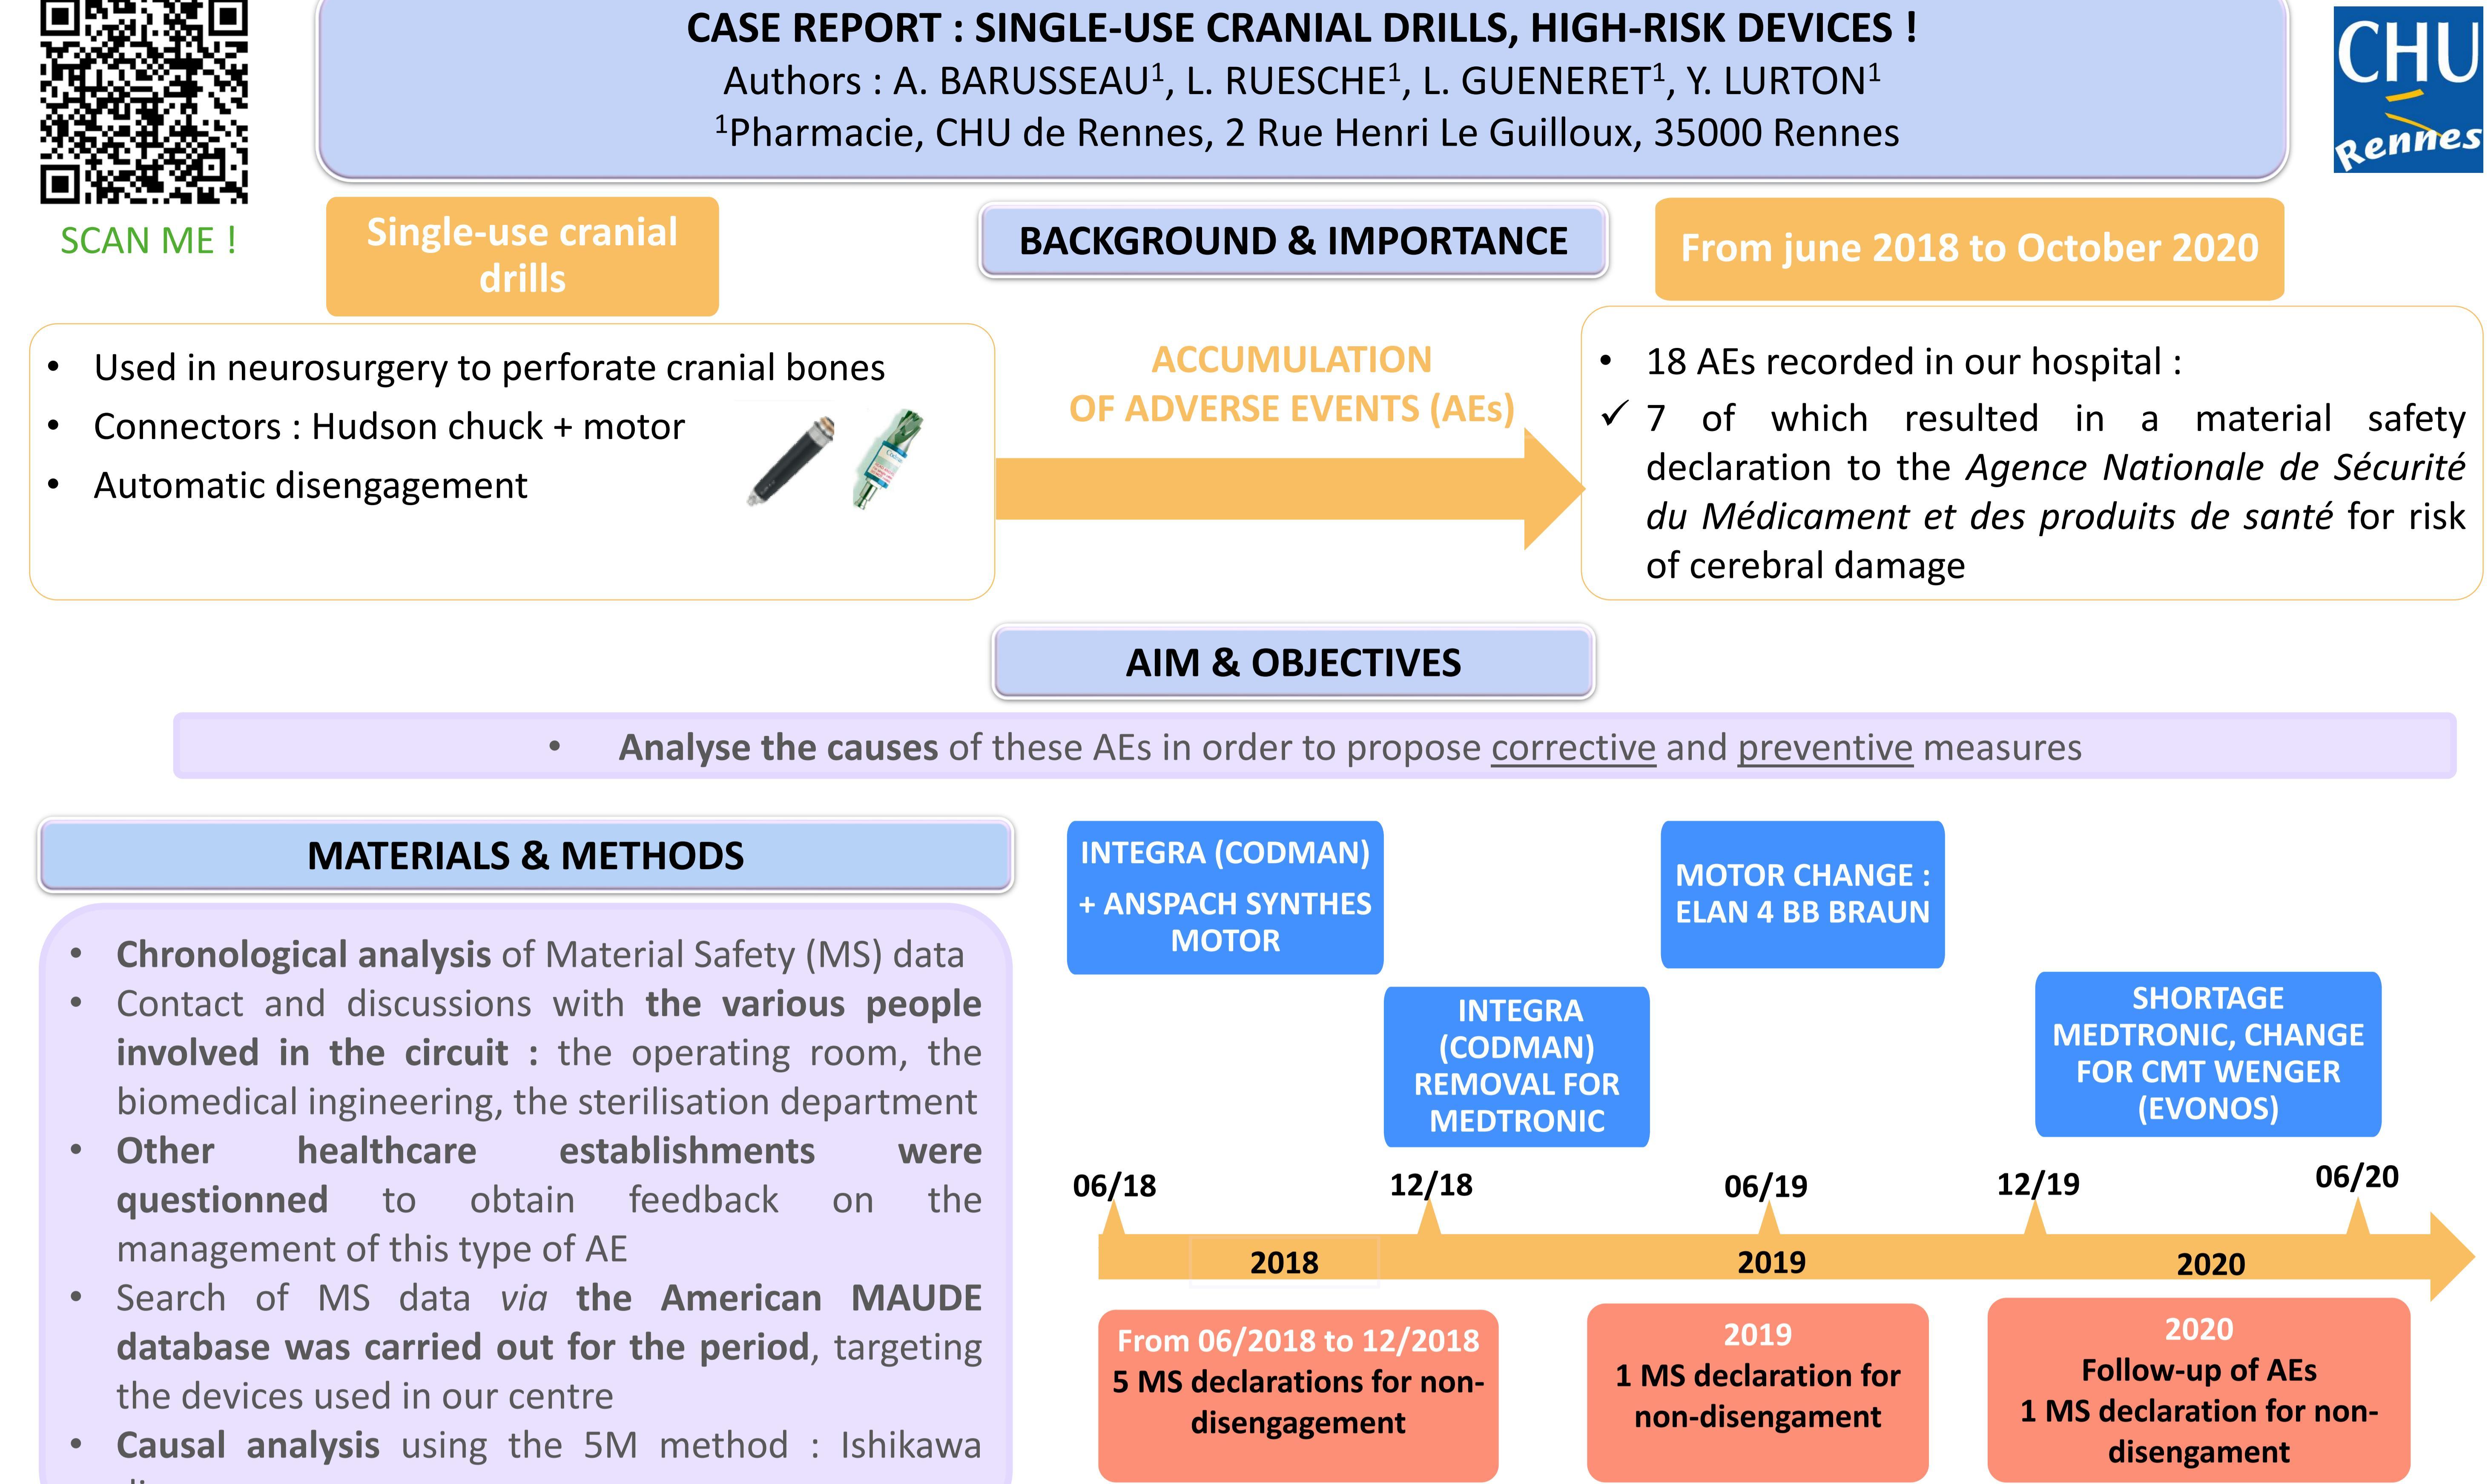
<u>Figure 1</u>: Timeline showing AEs and equipment for cranial drills and engines at Rennes University Hospital

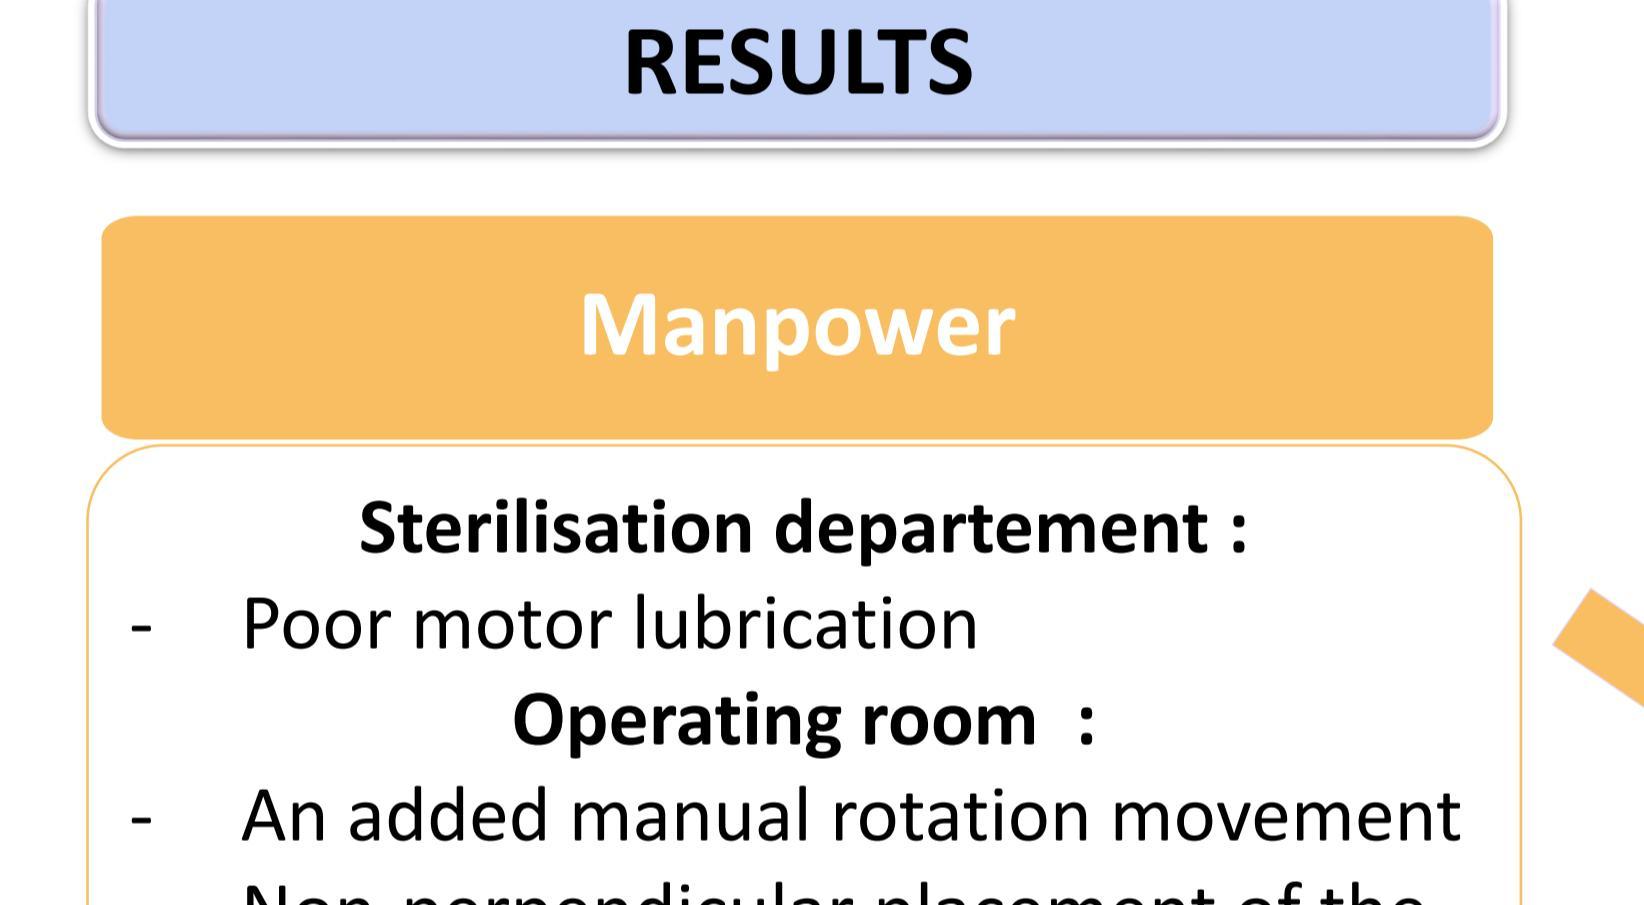
- Failure of the disengament mechanism
- Types of material for the connection tip : plastic vs. metal

- Connection between chuck
- and motor may be loose

- Non-perpendicular placement of the device
- Inappropriate rotation speed

- Pathological cranial bone
- Thickness of the cranial bone
- High intracranial pressure
- Adherence of dura mater

Agitated environment Connection of equipment making it difficult to use

- Inadequate training of the surgical team
- Faulty test procedure
- Unawareness of potential failure to disengage

Figure 2: Ishikawa Diagram for non-disengament of cranial drills

- ✓ Iterative change of supplier for cranial drills
- ✓ Training for the medical team : evidence of inappropriate motor rotation speed
- Monitoring of abnormal connection between chuck and motor nationally by the supplier

✓ Biomedical intervention: overhaul of motors, testing of a new Hudson chuck

✓ Integrate disengagement performance into cranial drills selection criteria
